GAMMA RADIATION SURVEYS AT INACTIVE URANIUM MILL SITES

August 1975

Technical Note
ORP/LV-75-5

OFFICE OF RADIATION PROGRAMS - LAS VEGAS FACILITY
U.S. ENVIRONMENTAL PROTECTION AGENCY
LAS VEGAS, NEVADA 89114

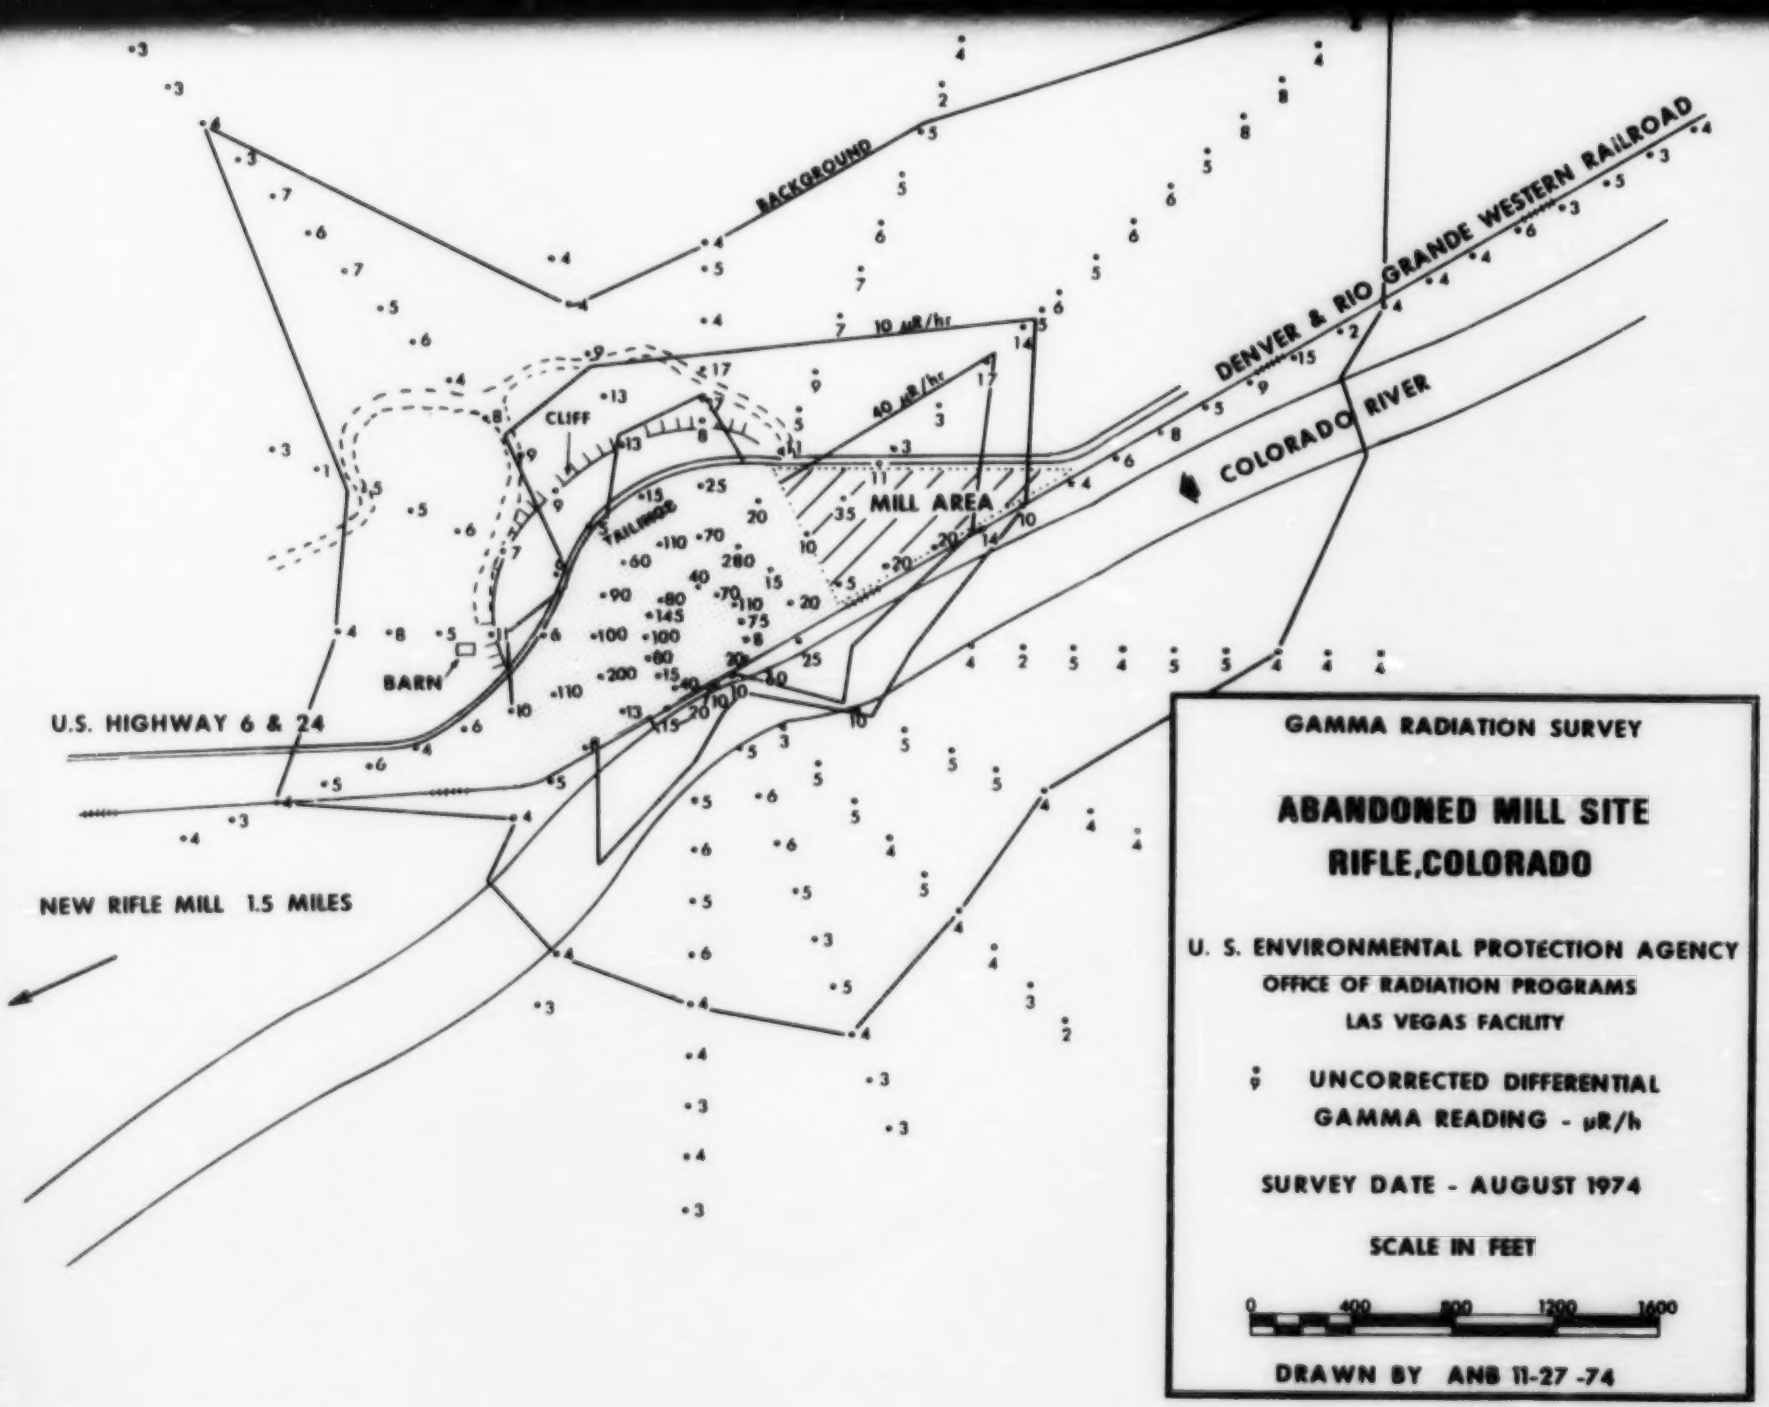
Figure 9

It should be noted that during the survey, Interstate 70 was under construction south of the site. This may affect the final location of the three lines once construction is completed.

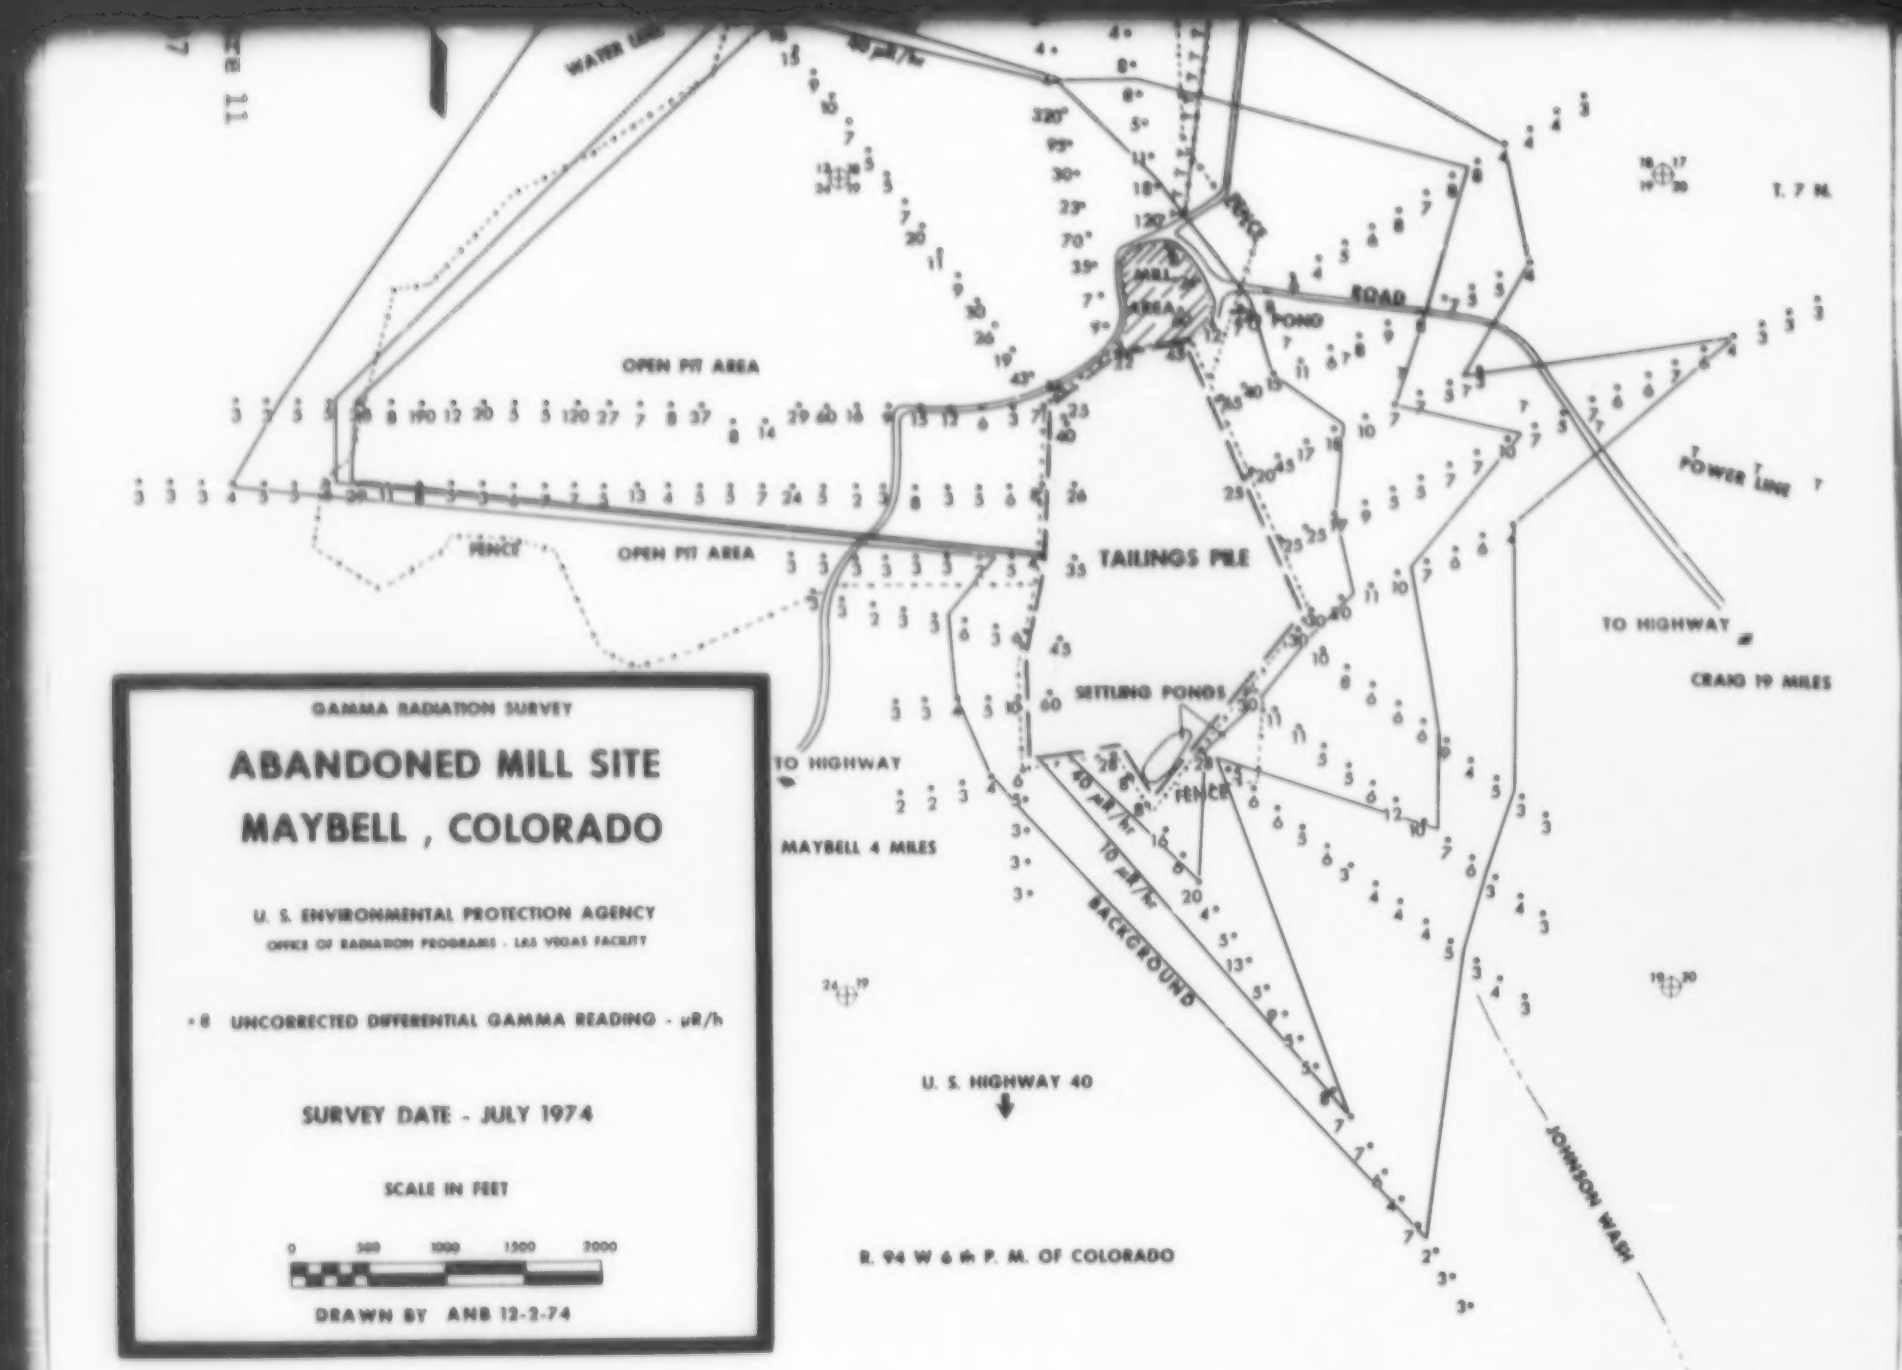
Tailings and/or mine waste spread, as indicated by the background line, varies from 600 feet north of the pile to 2200 feet east of the pile and 2400 feet south of the pile. A small area of hauled tailings was located near the trailer about 3000 feet south of the pile. An area about 2000 feet southeast of the pile had slightly elevated readings which were probably caused by low-grade ore close to the surface.

The 10 μR/hr line varies from 400 feet north of the pile to 1800 feet east of the pile and 2000 feet south of the pile. All but one of the overburden and mine waste piles lie within the 10 μR/hr line. Two small areas of elevated readings 1100 and 1700 feet south of the pile were probably caused by low-grade ore close to the surface. The 10 μR/hr line could not be closed in the area of the open pit, since no readings were taken in the pit.

establish the location of this line around the small mine waste pile. The 40 μR/hr line could not be closed in the area of the open pit, since no readings were taken in the pit.

Extensive tailings spread to the east was caused by the frequent high winds from the west. The lower level contamination to the south of the pile is probably the result of the general spread of the low-level mine waste that was dumped in that area.

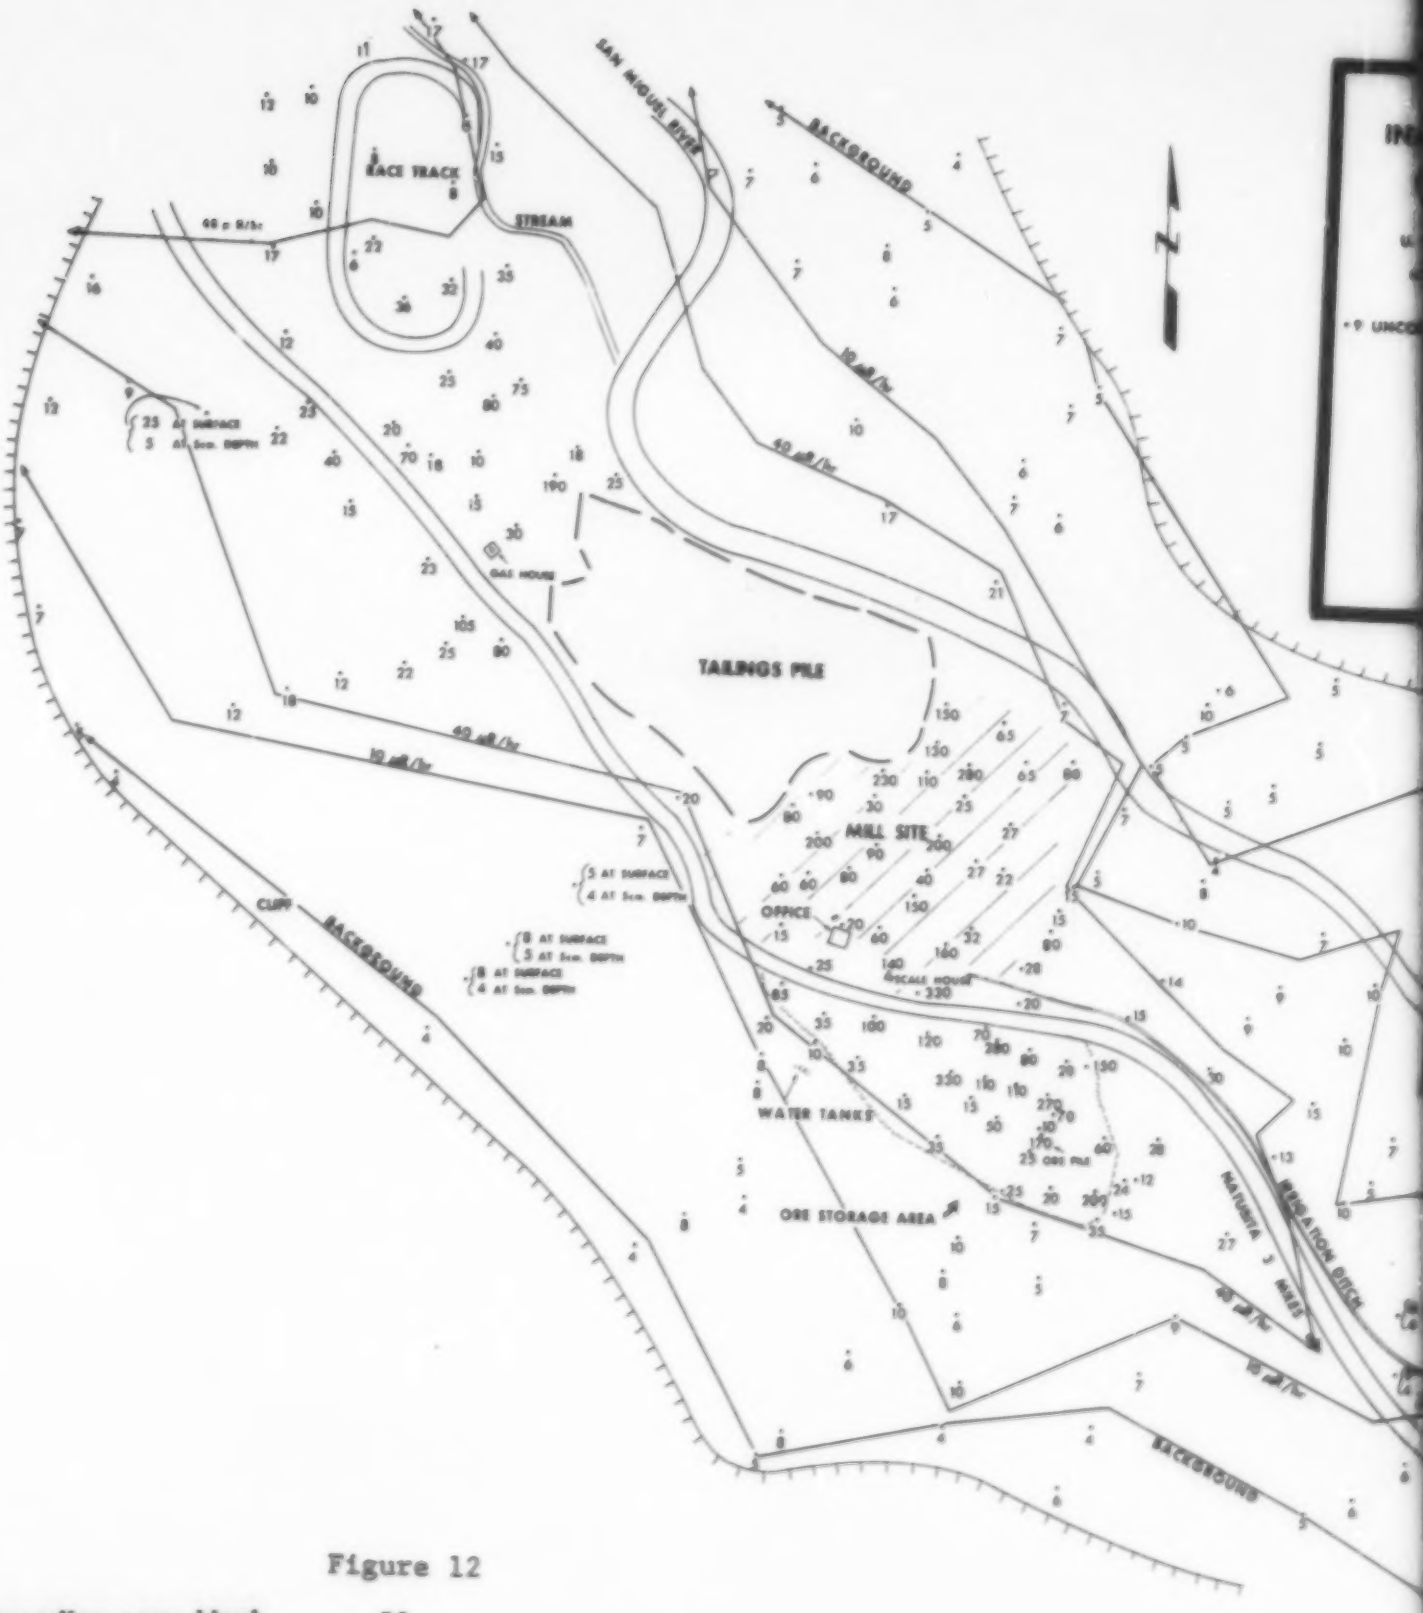
Figure 12

The majority of the survey points for the Naturita site were located using a theodolite and stadia rod. Extensive contamination of the canyon caused by the plume from the old roaster stack was found in the down-valley direction, so it was necessary to place survey locations across the canyon for several miles downstream. The theodolite was set up at five different locations in order to cover the millsite area. The instrument locations were tied to one another using the instrument and the stadia rod. Instrument readings were taken at about 200-foot intervals along radials from the instrument locations.

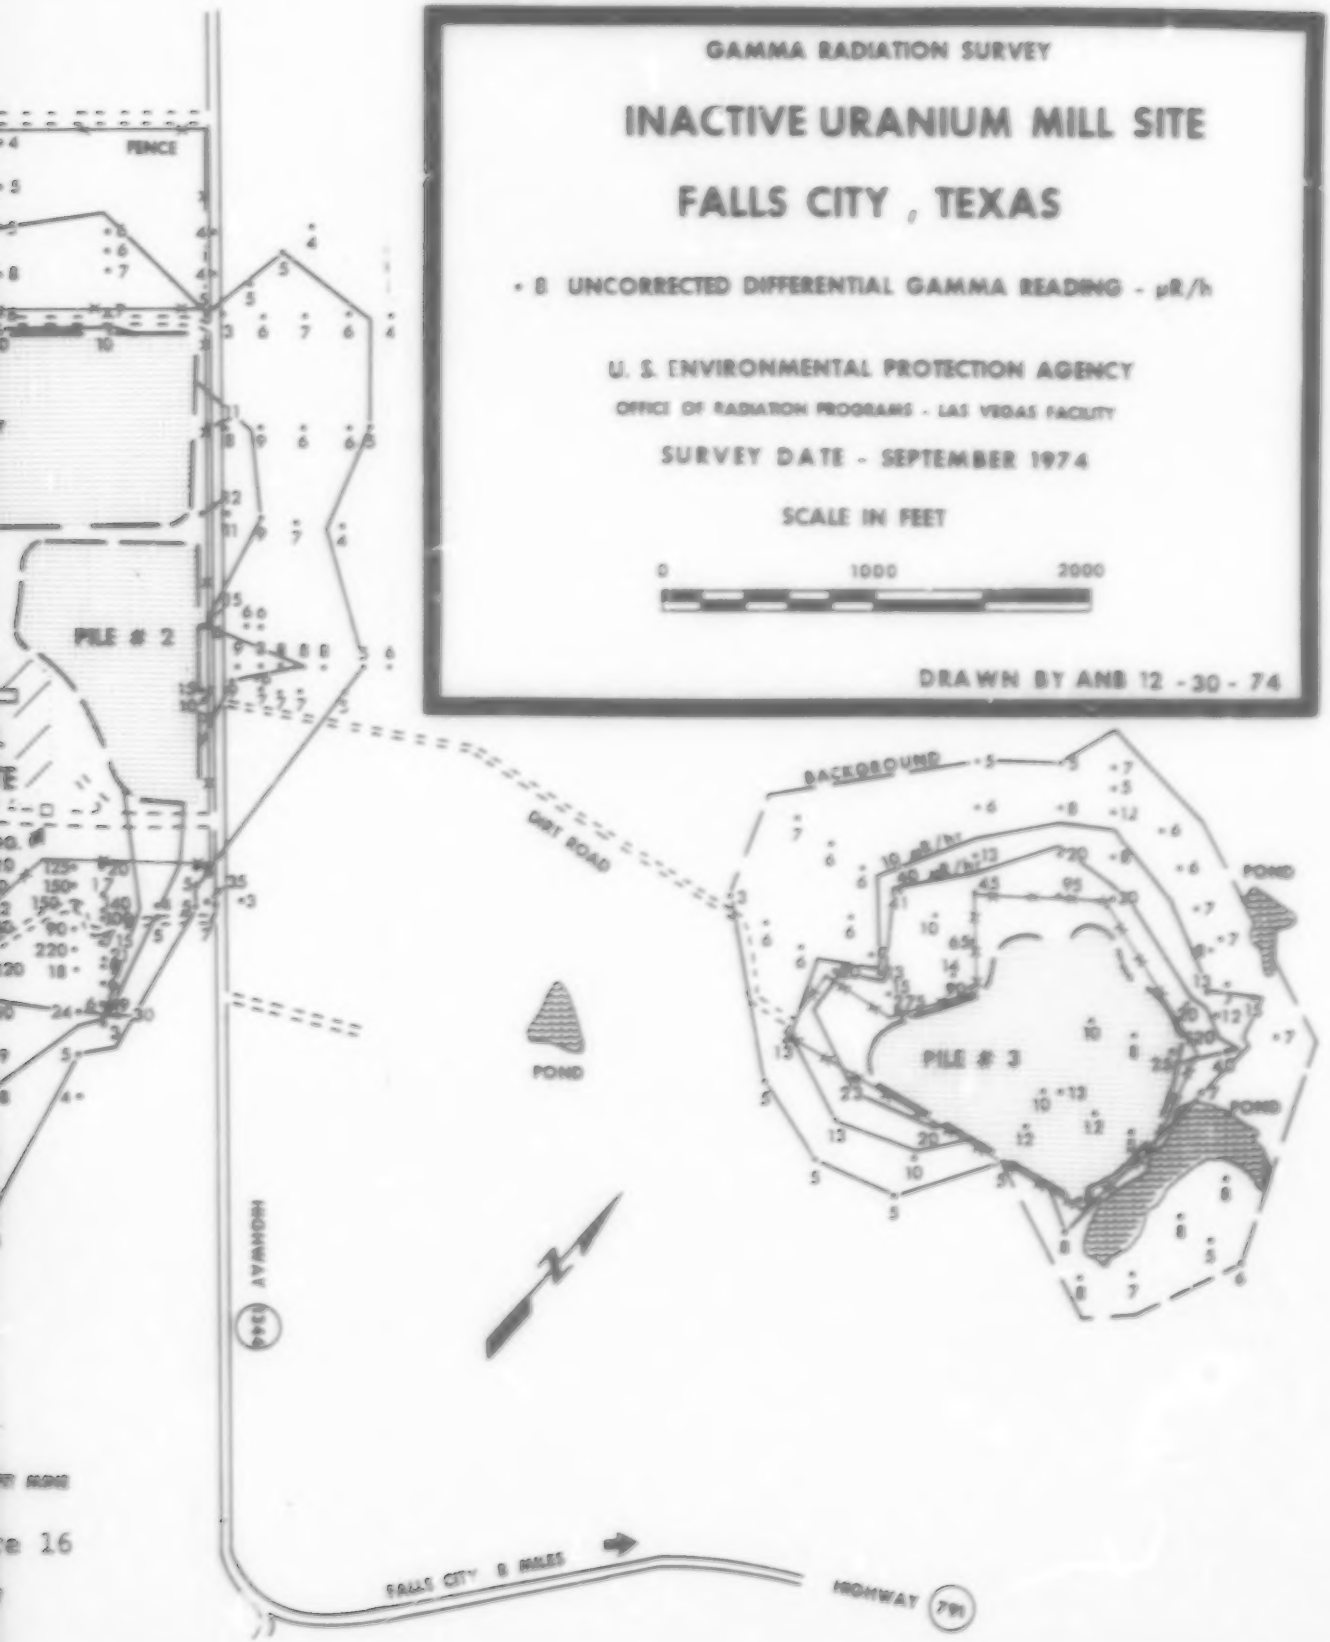
Survey points for the Falls City site were located by establishing base lines around both the major site and minor site (pile #3). The base lines were located along established landmarks and fences. Where necessary, the base lines were accurately measured to maintain the accuracy of the survey. Perpendicular traverses were paced from the base lines and delta measurements were made at specified intervals (usually 200 feet) until the background delta was found. Background delta values varied between 3 and 5 because of ore body locations close to the ground surface throughout the site area.

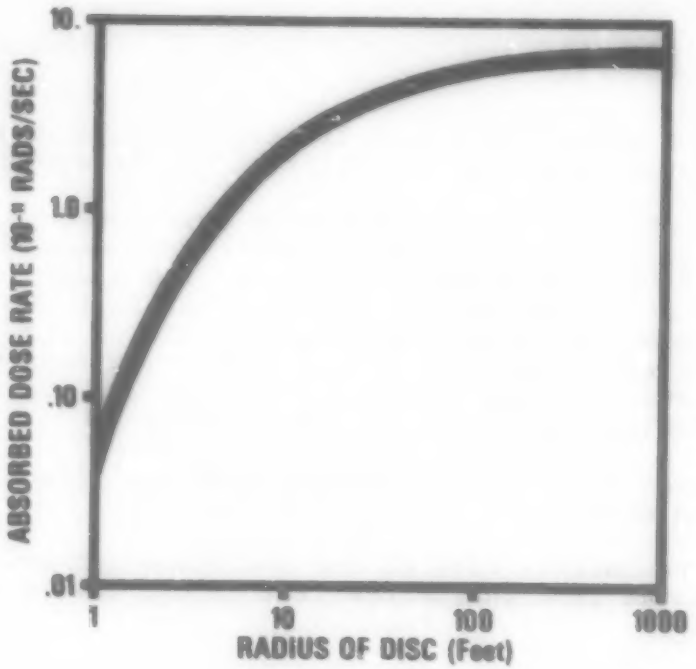
Figure A-2
Gamma Absorbed Dose Rate on the Axis (3 feet above disc) of a Plane Disc from a Uniform Surface Contamination (ω) of 1 pCi/cm^2 of ^{226}Ra with its Progeny in Equilibrium vs Radius of Disc.

Absorbed dose rates vs. disc radius are shown in Figure A-2. Delta values corresponding to an above-ground exposure rate can be obtained from Figures A-1 and A-2.
